## GEOSYNTHETICS TEST REPORT

REPORT REFERENCE: BS-T331/a

**Material Tested** Concrete Canvas

**Tests Requested** Resistance to Roots - PD CEN/TS 14416:2014\*

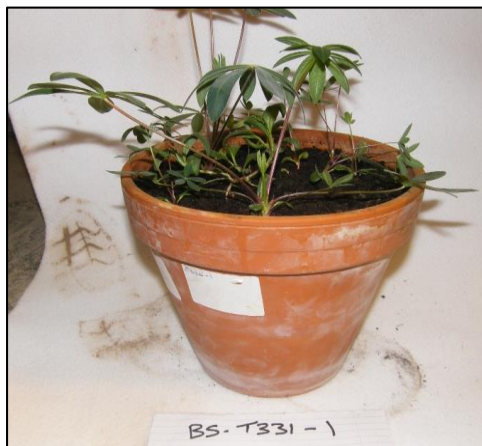
Sample 1

The exposed top side and the underside of the Root Barrier have been inspected. Photographs have been taken to show the top and underside surface of the test samples. The roots have not penetrated through the Root Barrier.

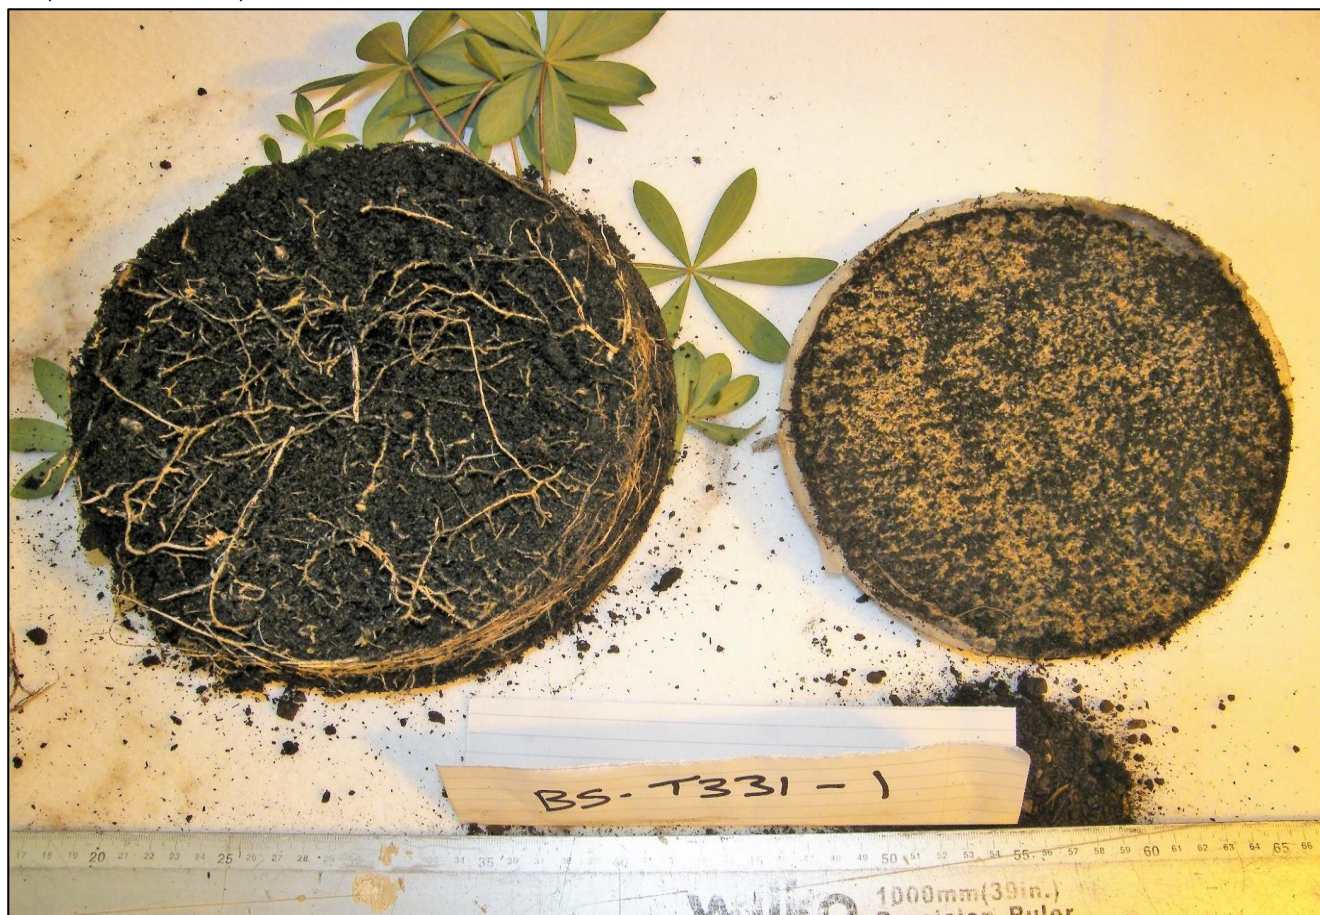
Specimen 1

The roots have not penetrated the specimen. The photographs show the underside of the sample and the roots at the top of the barrier interface.

The sample has resisted root penetration under the conditions of PD CEN/TS 14416:2014\*

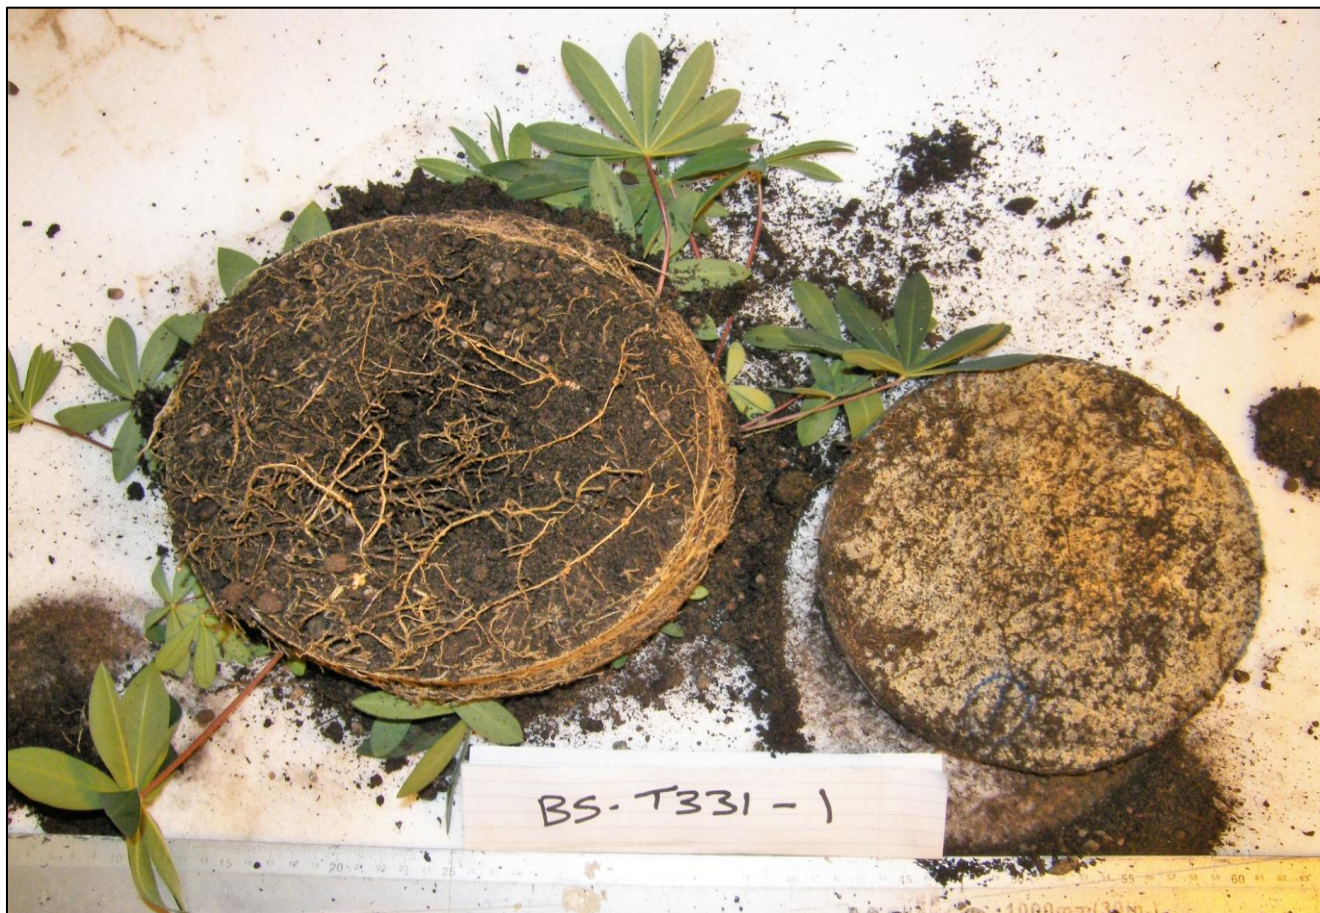
Specimen 2

The roots have not penetrated the specimen. The photographs show the underside of the sample and the roots at the top of the barrier interface.

The sample has resisted root penetration under the conditions of PD CEN/TS 14416:2014\*

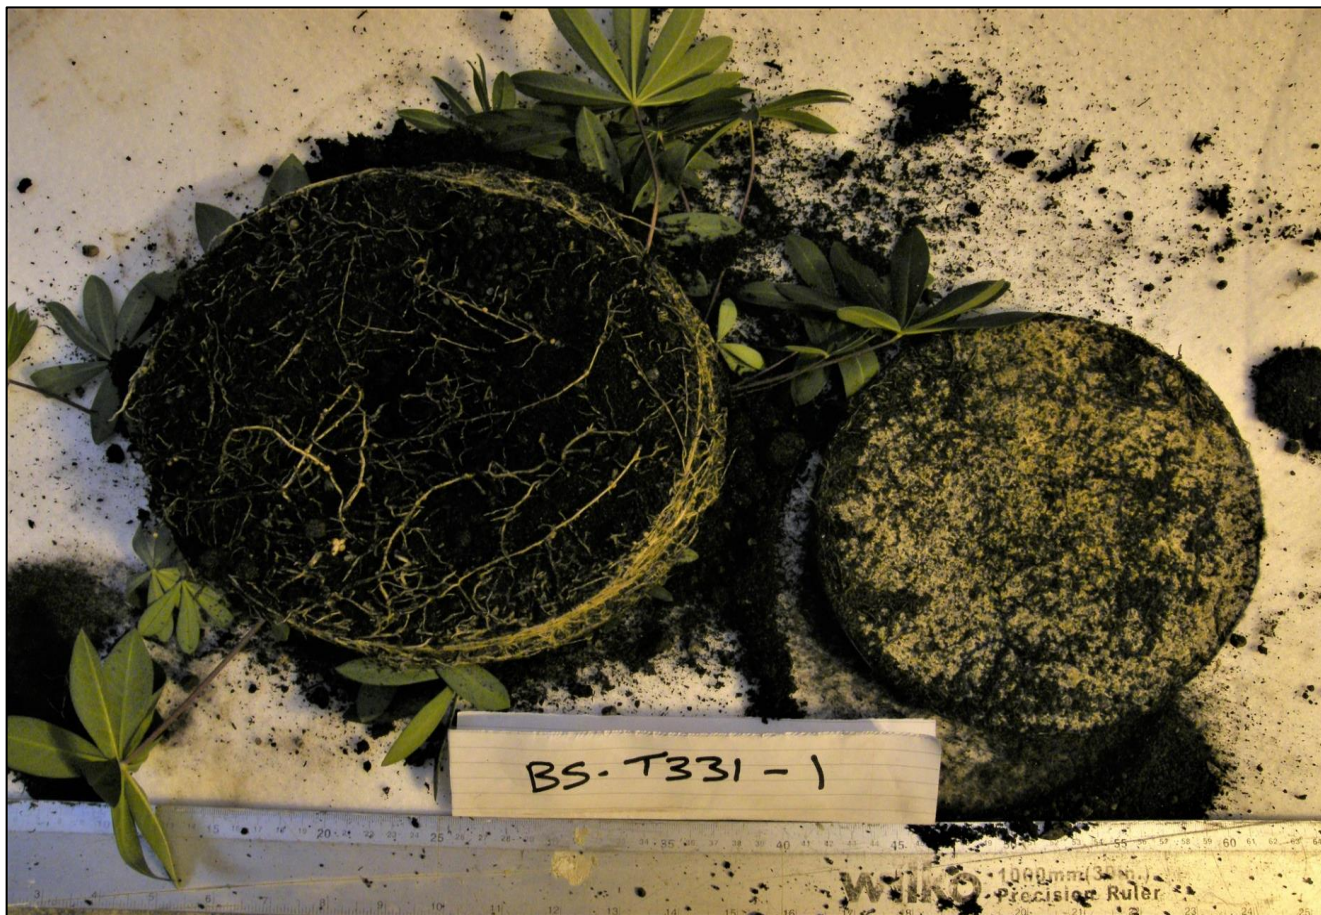
Specimen 3

The roots have not penetrated the specimen. The photographs show the underside of the sample and the roots at the top of the barrier interface.

The sample has resisted root penetration under the conditions of PD CEN/TS 14416:2014\*

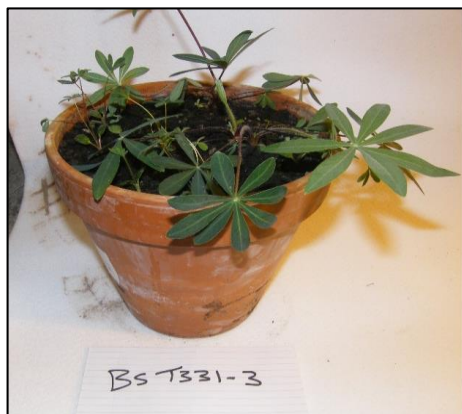
Sample 1

The exposed top side and the underside of the Root Barrier have been inspected. Photographs have been taken to show the top and underside surface of the test samples. The roots have not penetrated through the Root Barrier.

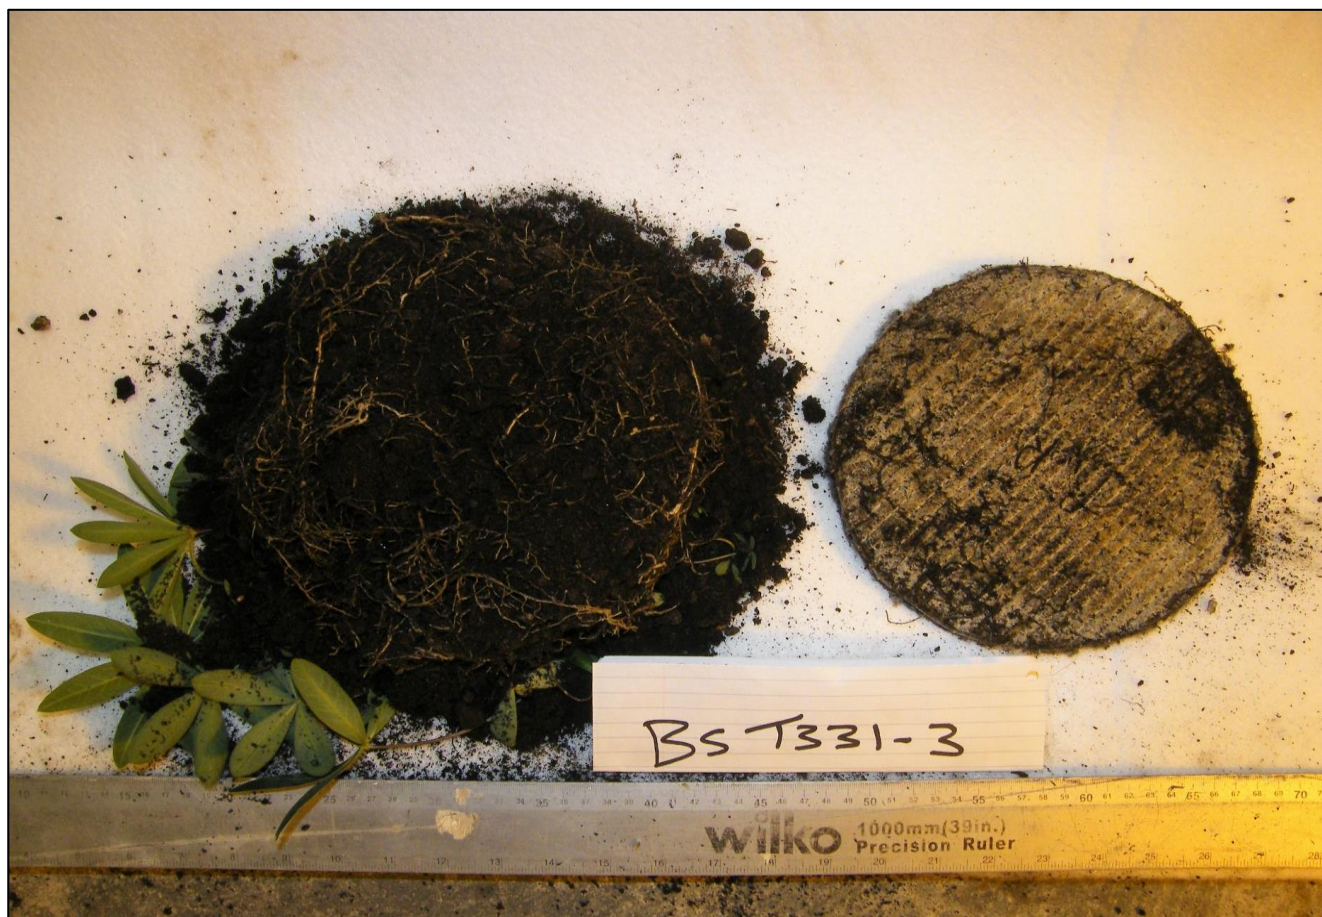
### Specimen 1

The roots have not penetrated the specimen. The photographs show the underside of the sample and the roots at the top of the barrier interface.

The sample has resisted root penetration under the conditions of PD CEN/TS 14416:2014\*

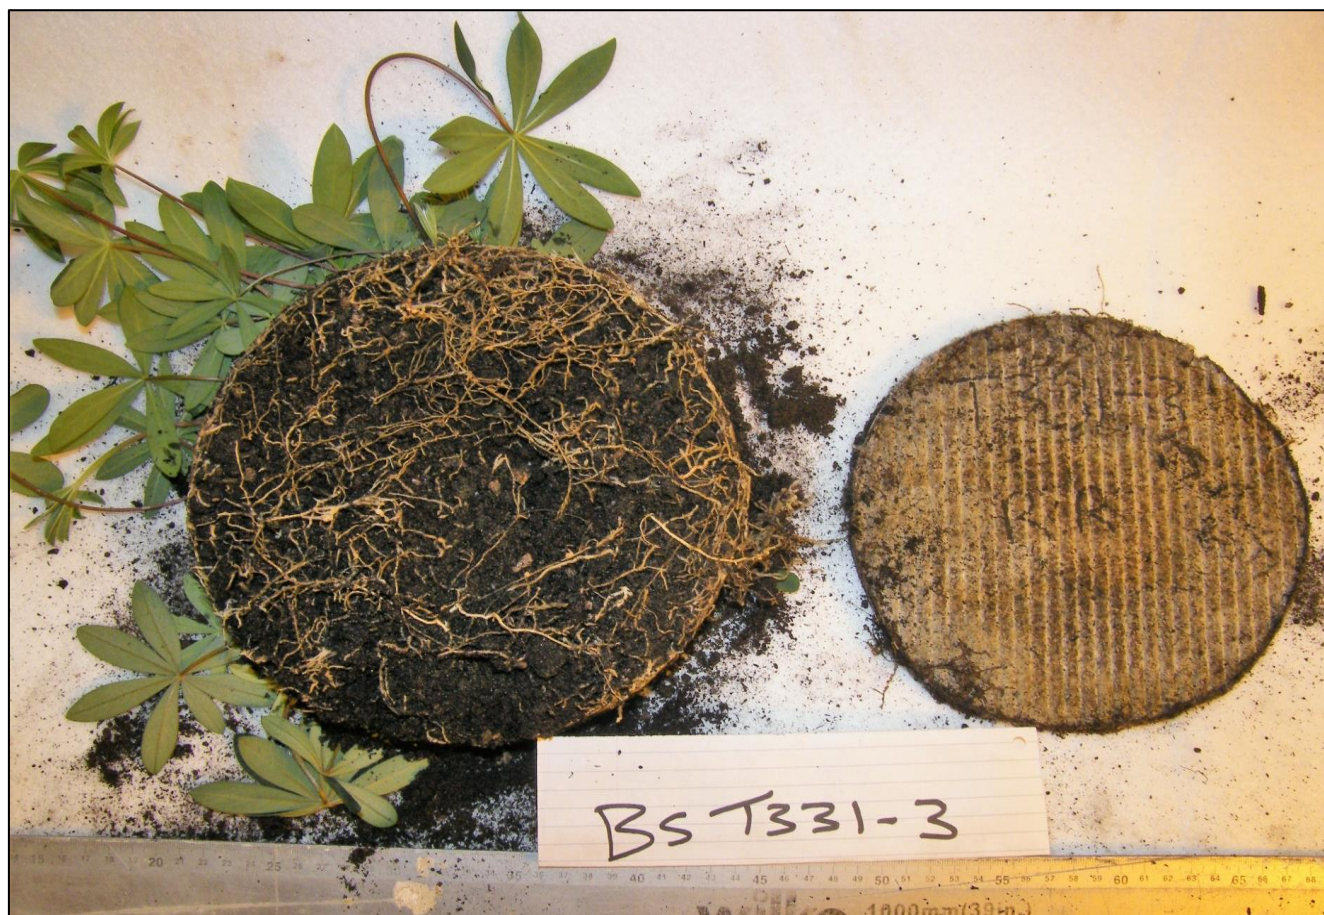
Specimen 2

The roots have not penetrated the specimen. The photographs show the underside of the sample and the roots at the top of the barrier interface.

The sample has resisted root penetration under the conditions of PD CEN/TS 14416:2014\*

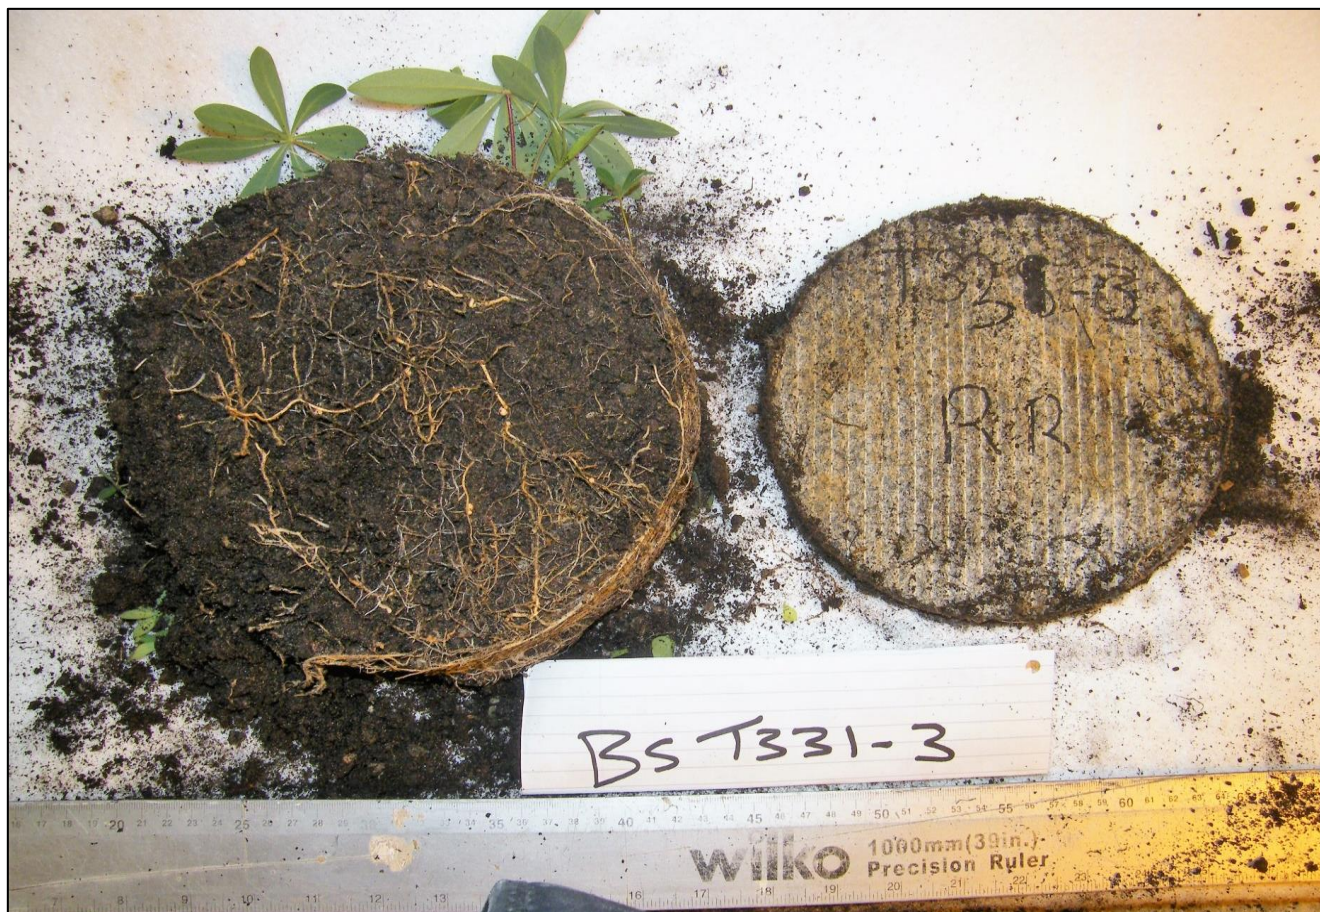
Specimen 3

The roots have not penetrated the specimen. The photographs show the underside of the sample and the roots at the top of the barrier interface.

The sample has resisted root penetration under the conditions of PD CEN/TS 14416:2014\*
